REPAIR SOLUTION FOR THE AXLE JOURNALS OF PSA REAR AXLES

TECHNICAL INFO NO. 1106

VEHICLE M	ANUFACTURER/MODELS:	
Peugeot	106 205 206 20600 306 309

Citroen Xsara, AX, ZX, Saxo

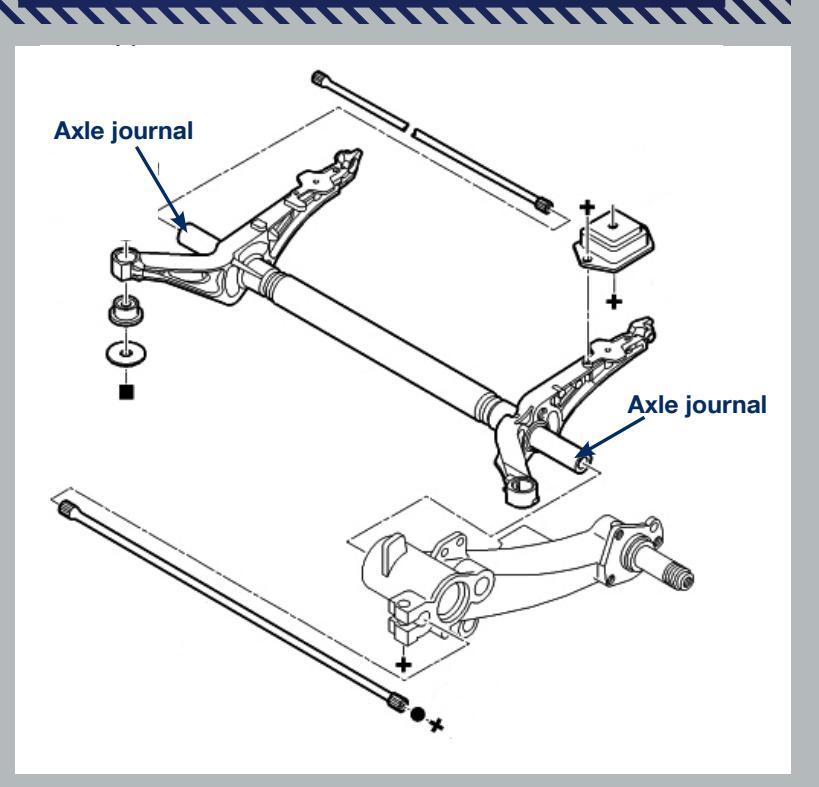
Image 1: PSA Rear axle

The rear axle (Image 1) in various vehicles of the PSA Group is subject to comparatively high wear.

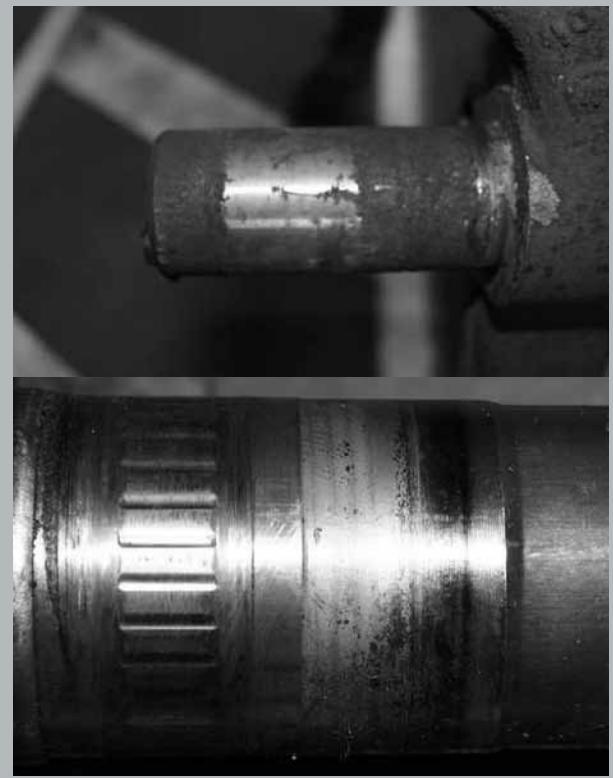
Image 2: Pictures of damage

In addition, if the vehicles are left standing most of the time, the gaskets are not adequately lubricated so that water can penetrate, leading to extensive corrosion of the axle journal (Image 2) which destroys the bearings.

Axle journals and bearings damaged to this extent cause operating noises from the axle and tilting of the rear wheels. Vehicles showing these signs of damage are not safe to run on the roads and will fail the general roadworthiness inspection.

Up to now, the only possible solution was to replace the whole rear axle because the axle journals are normally not available as individual spare parts.

RUVILLE has taken up the challenge presented by this problem and developed a special tool (Fig. 3) which can now be used to replace the axle journals.

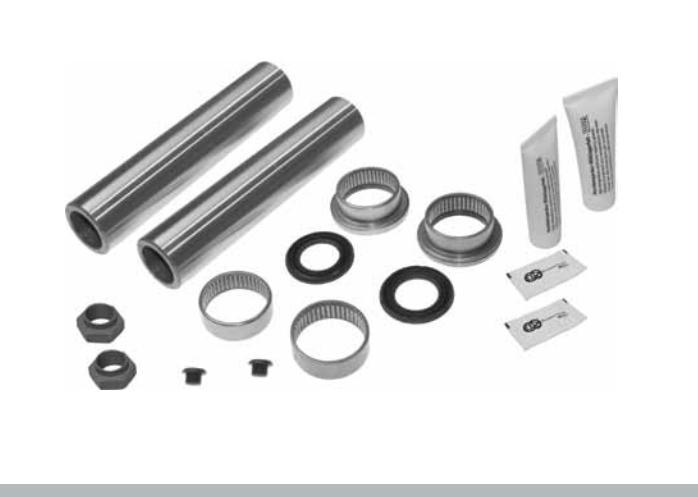
Image 4: Example of a repair kit 965905S

The journals are part of a comprehensive repair kit (Fig. 4) that permits economic repairs.

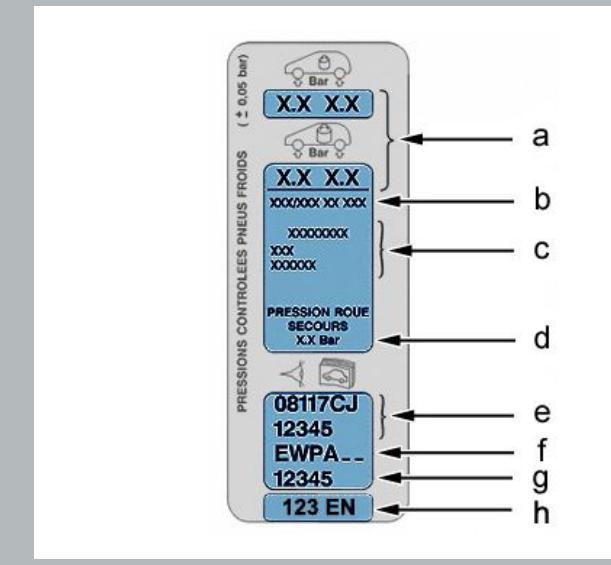
Image 5: Example 1

This number consists of a combination of 12 numbers/letters in two lines, which can be found on the affected vehicles on an identification plate on the left B-pillar, at position "e" on the plate.

Example of how to decode the Organization No. Characters 1-5 (upper line): 08117 = Organization No. Characters 6+7: CJ = plant Character 8: 1 = production line Characters 9-12: 2345 = manufacturing order No.

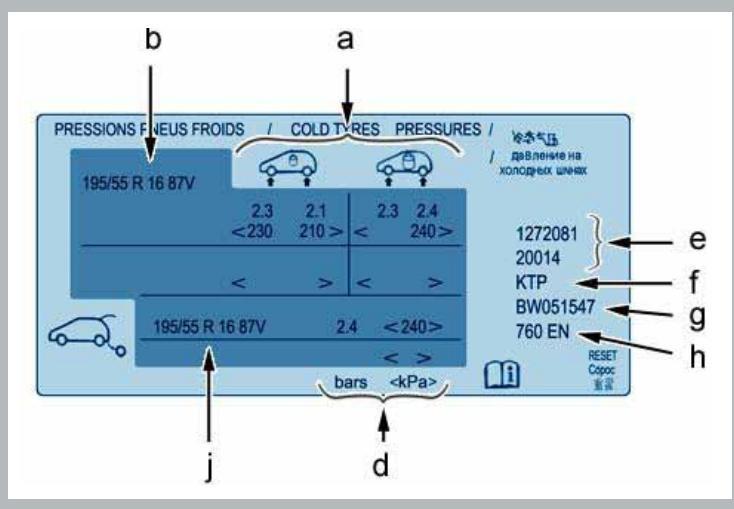
Image 6: Example 2

The two rear axle versions of the 206 CC are differentiated by the Organization No. 09500 88 (= manufactured on 12 November 2002 at the plant in Mulhouse).
